Berryman

June 29, 2018

**Re: Patrick Pete Stover and
Sheri Lynn Stover, Plaintiffs
v.
State Farm Fire and Casualty
Company, a foreign for-profit
insurance corporation,
Defendant
United States District Court o
Western District of Oklahoma
Case No.: CIV-17-1002-HE**

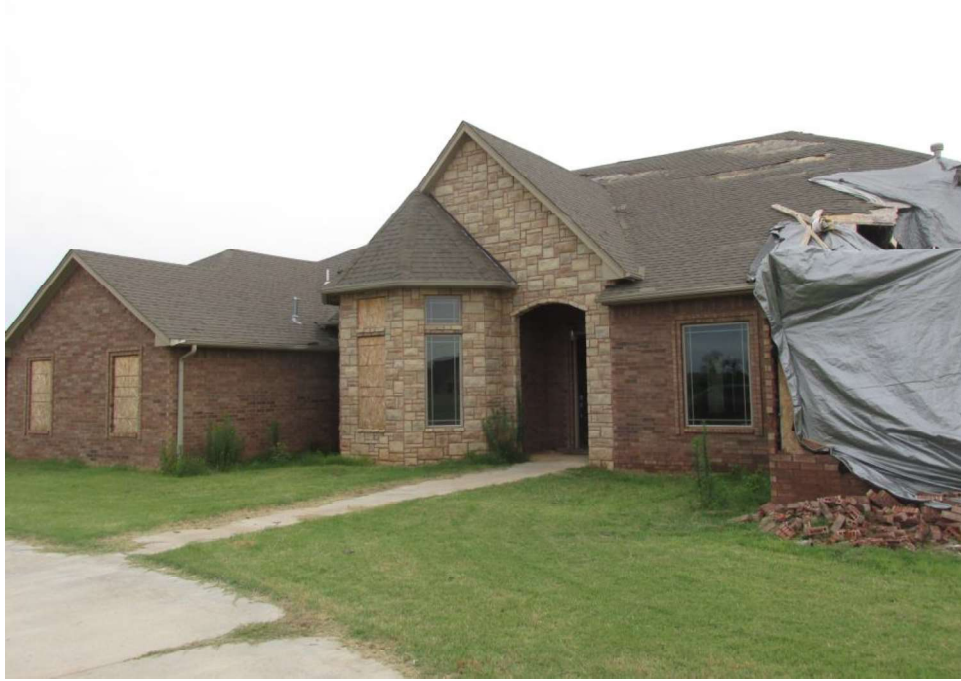
Photo 1: Front of the subject property

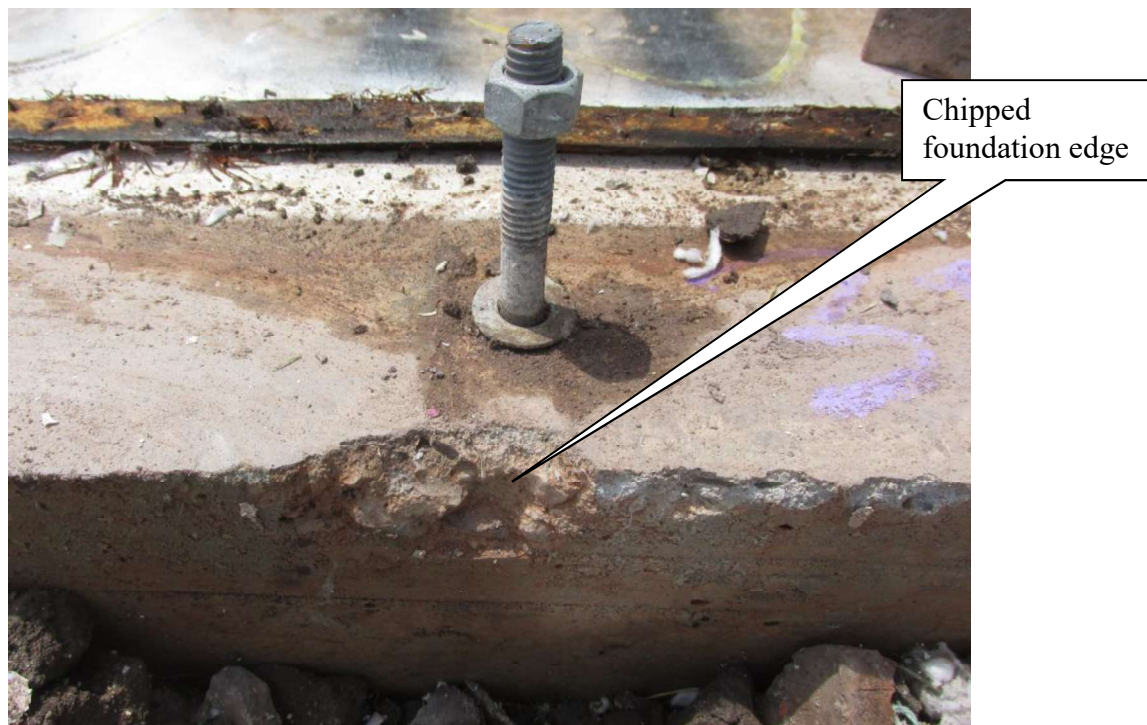
1.1.3. *He believed he observed slab and anchor bolt damage at the southeast corner of the residence.* I conducted a closer inspection of the same area and determined that the home's anchor bolts were undamaged.

- One surface shrinkage crack and some chipping of the leading edge of the slab were noted in a few places at the southeast corner of the slab.
- There is evidence that some of the chipping was likely induced at the time of original construction methods, e.g. there is evidence that concrete nails were used to fasten the framing bottom plate to the slab at the fracture point.
- The aberrations are cosmetic and of no consequence in the future performance of the foundation. They can be repaired using conventional concrete restoration methods.
- They will be concealed from view once the home is repaired and they are incorporated into the finished wall assembly.
